Re: GE-Pittsfield/Housatonic River Site

Newell Street Area II (GECD450)

Summary of September 2007 Inspection of the Natural Resource Restoration/

**Enhancement Area**

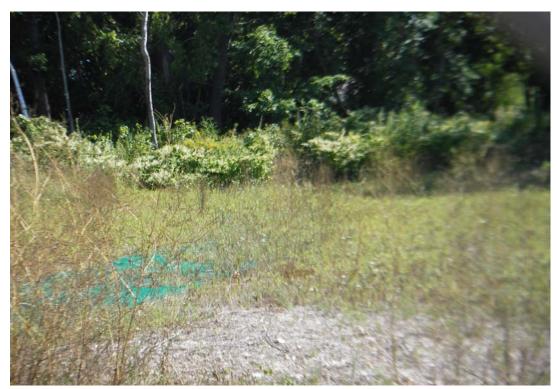
Photo #3: Vegetation of the fenced enclosure, looking south.

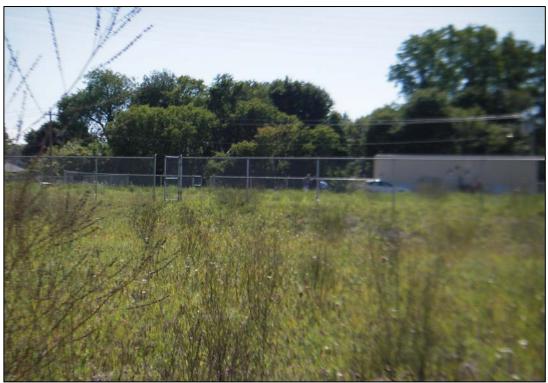
Photo #4: Vegetation of the fenced enclosure, looking southwest.

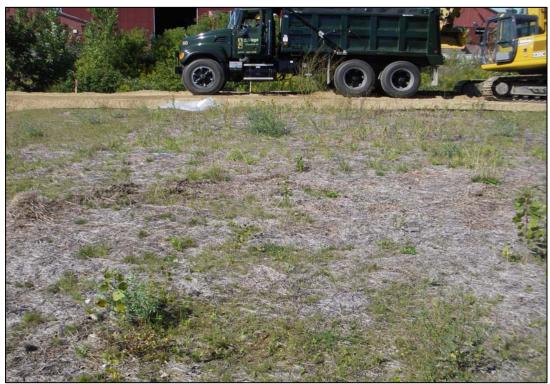
Photo #7: Area immediately northwest of the northwest corner of the fenced enclosure, looking north.

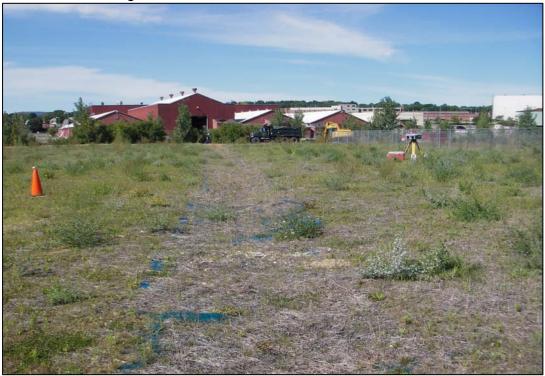
Photo #8: Drainage ditch east of the access road, looking north.
